Contract #: 04-0120F4Cty: SF/ALA Rte: 80 PM: 13.2/13.9File #: 69.28**WELDING INSPECTION REPORT****Resident Engineer:**Siegenthaler, Peter**Address:** 333 Burma Road**City:** Oakland, CA 94607**Report No:** WIR-021133**Date Inspected:** 06-Oct-2010**Project Name:** SAS Superstructure**OSM Arrival Time:** 700**Prime Contractor:** American Bridge/Fluor Enterprises, a JV**OSM Departure Time:** 1900**Contractor:** Zhenhua Port Machinery Company, Ltd (ZPMC), Changxing Island **Location:** Shanghai, China**CWI Name:** Li Yan Hua**CWI Present:** Yes No**Inspected CWI report:** Yes No N/A**Rod Oven in Use:** Yes No N/A**Electrode to specification:** Yes No N/A**Weld Procedures Followed:** Yes No N/A**Qualified Welders:** Yes No N/A**Verified Joint Fit-up:** Yes No N/A**Approved Drawings:** Yes No N/A**Approved WPS:** Yes No N/A**Delayed / Cancelled:** Yes No N/A**Bridge No:** 34-0006**Component:** OBG Segment Assembly**Summary of Items Observed:**

WELDING INSPECTION REPORT

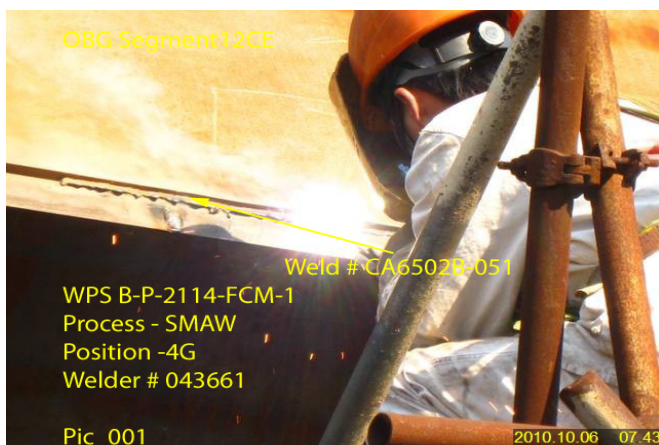
Shielded Metal Arc Welding (SMAW) in the 4G position of weld joint CA6502B-051 located on Bike Path side Drain Plate. The welder is identified as 043661. ZPMC Quality Control (QC) is identified as Wang Xiang Pin. The welding variables recorded by QC appeared to comply with the WPS B-P-2114-FCM-1. See attached photograph Pic_001.

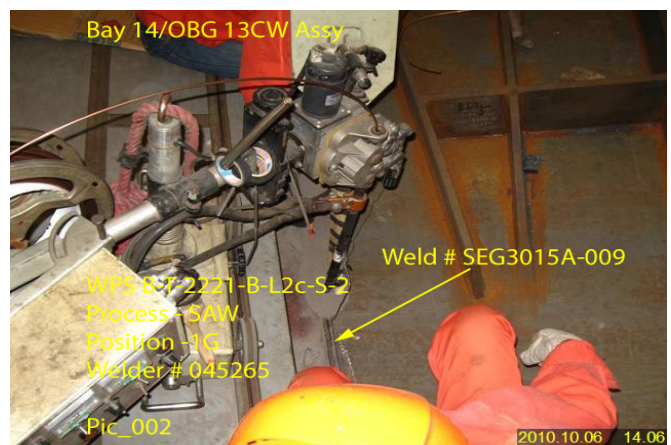
Sub Arc Welding (SAW) in the 1G position of weld joint SEG3015A-009 located on Counterweight side Bottom Panel (BP3070A+BP3071A) to Side Panel (SP3107A) long seam. The welder is identified as 045265. ZPMC CWI is identified as Wang Jie. The welding variables recorded by QC appeared to comply with the WPS B-T-2221-B-L2c-S-2. See attached photograph Pic_002.
